Manhole Inspection Summary

Manhole # S35GG_005MH

Location Address: **209 MOUNT ROYAL AVE**

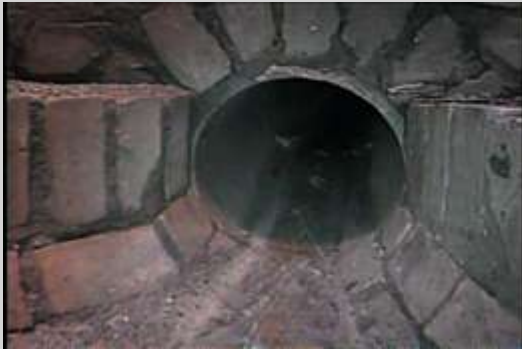
8 in. Circular Gravity Sewer Pipe Out @ 12 O'Clock

Pipe Material: **Clay** ☐ Pipe Lined

Infiltration: **None** Pipe Seal Cond: **Unknown**
